**Flood Control Project Maintenance
Levee Inspections**
LMA District Cover Sheet
Spring 2020 Levee Inspection Results

Lower San Joaquin Levee District

Spring 2020 Levee Inspection Results

Waterway			Bank	Unit Miles
Unit No. 01 San Joaquin River			Right	22.52
	Spring (March - May)	Summer (June - August)	(September - November) Fall	Winter (December - February)
Unit Maintenance Rating (Fall Only)				
Date of Inspection	4/21/2020 - 4/21/2020			
DWR Inspector	Corey Fujitani			
Accompanied By

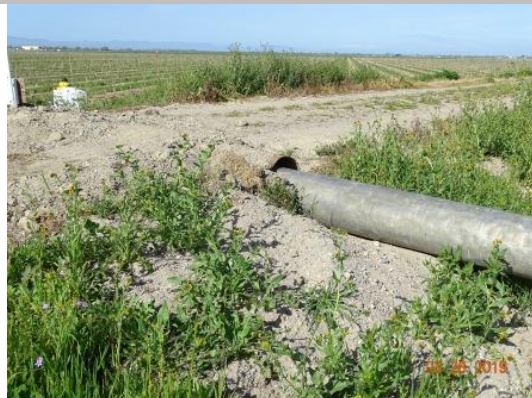
Photo 1 of 2 : SP_2020_NA0010_124_127_20200225_00061.jpg

LM Start	28.18	Rating **	A/W	Issue No.	127
LM End	28.18	Issue Type +	En	Location *	CR
Category	Earthen Levee			GPS Latitude/Longitude	
				Start	End
Item	Encroachments			37.030924 °	37.030924 °
				-120.478411 °	-120.478411 °
DWR ID	DWR_NA0010_06_s_2019_127				
Comment Code					
PI : Pipe					
Inspector Comment					
Landowner has installed pipe in levee crown.

View of pipe crossing looking southeast. (Spring 2019)

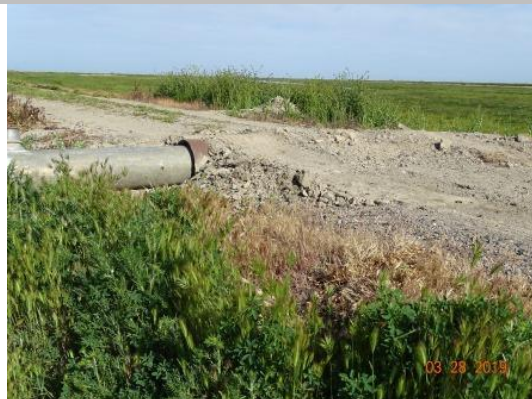
Photo 2 of 2 : SP_2020_NA0010_124_127_20200225_00062.jpg

View of pipe crossing looking south. (spring 2019)

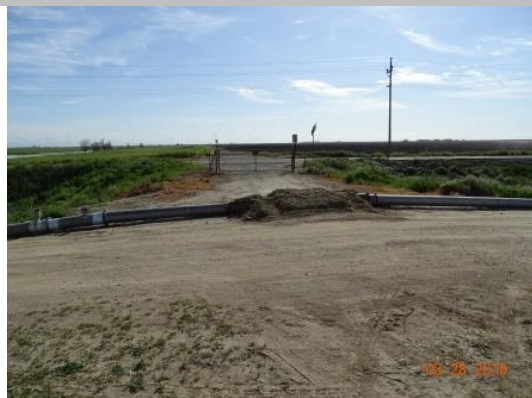
Photo 1 of 3 : SP_2020_NA0010_124_110_20200225_00054.jpg

Landowner has installed a temporary pipe across the levee. The size of the pipe and short ramp increases the chances of vehicles bottoming out.

View of temporary pipe looking upstream. (Spring 2019)

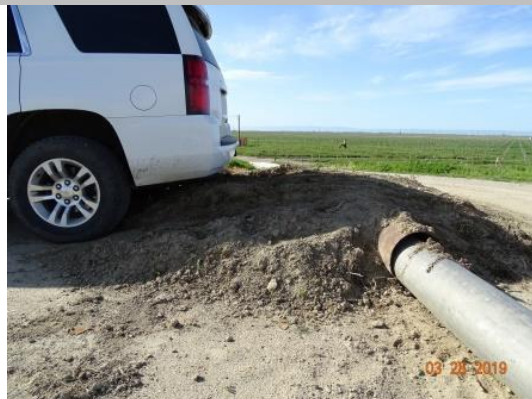
Photo 2 of 3 : SP_2020_NA0010_124_110_20200225_00055.jpg

View of pipe crossing looking West. (Spring 2019)

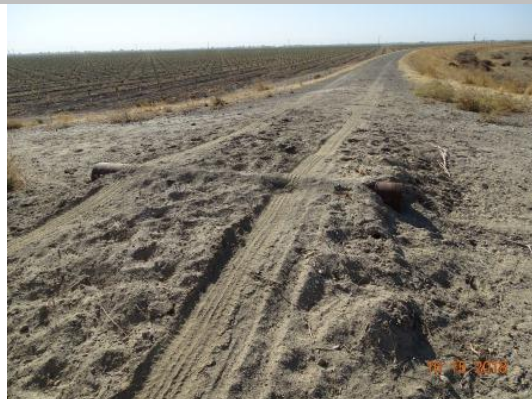
Photo 3 of 3 : SP_2020_NA0010_124_110_20200225_00056.jpg

Landowner has installed a temporary pipe across levee crown. (Fall 2018)

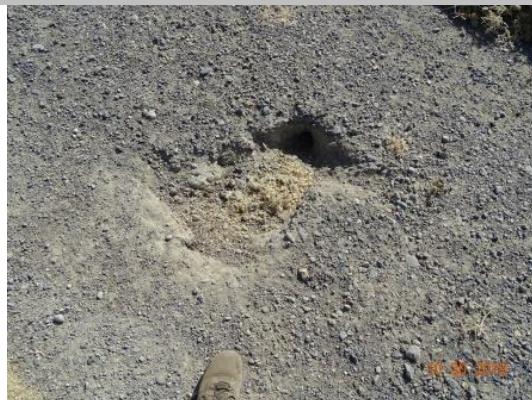
Photo 1 of 1 : SP_2020_NA0010_124_19_20200225_00011.jpg

LM Start	28.47	Rating **	M	Issue No.	19
LM End	28.53	Issue Type +	Ma	Location *	LS
Category	Earthen Levee			GPS Latitude/Longitude	
				Start	End
Item	Animal Control			37.029937 °	37.029977 °
				-120.473384 °	-120.472266 °
DWR ID	DWR_NA0010_06_s_2015_19				
Comment Code					
A3 : No rodents visible, but rodent burrows visible; need to backfill and compact or grout burrows.					
Inspector Comment					
Rodent burrows are also on the crown.

View of rodent burrow in the levee crown. (Fall 2019)

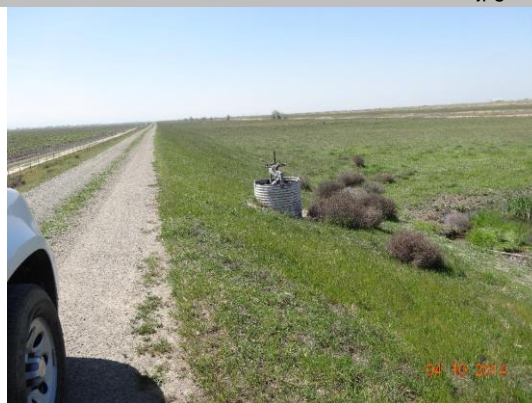
Photo 1 of 3 : UCIP_SP_2020_39886_66600.jpg

Comment Code					
Inspector Comment					
DS_ID:19881 FS_ID:39886 EP_NO: N/A Repair Type: Non-Urgent Crossing Status: Found UCIP Comments: 04/10/2014 Dense vegetation limits the inspector's visibility to identify signs of pipe failure (leaks) along the slopes. Recommend removing vegetation along pipe alignment to conduct proper inspection of structure. (DWR UCIP - O. Magana) FIELD_STRUCT_DESC: 36-inch corrugated metal gravity irrigation pipe through the levee, 12.4 feet below the crown. Slide gate in a 48-inch corrugated metal pipe (CMP) riser on the waterside (WS) slope. Concrete U-shaped headwall on each end. Cobble pad on the landside (LS). [Additional Reference(s): DWR Levee Log, 2002. USACE San Joaquin O&M Manual 601.1, 1967, (HLM 29.34)]. FS Date: 4/10/2014

View of waterward side--slide gate inside CMP riser located on waterward slope.

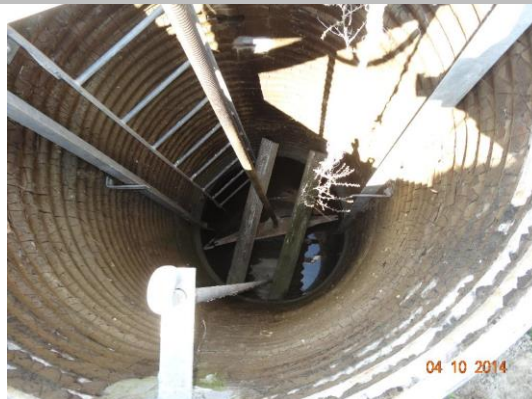
Photo 2 of 3 : UCIP_SP_2020_39886_66603.jpg

Inside view of CMP riser located on waterward slope.

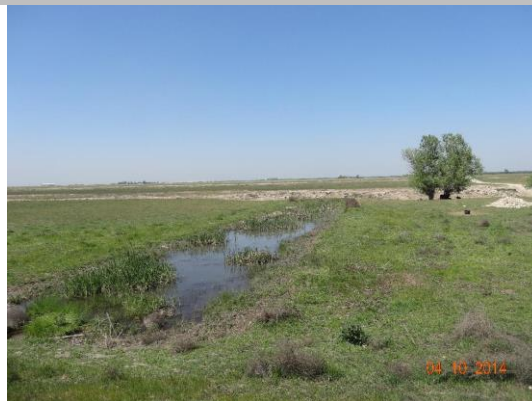
Photo 3 of 3 : UCIP_SP_2020_39886_66599.jpg

View of waterward side.

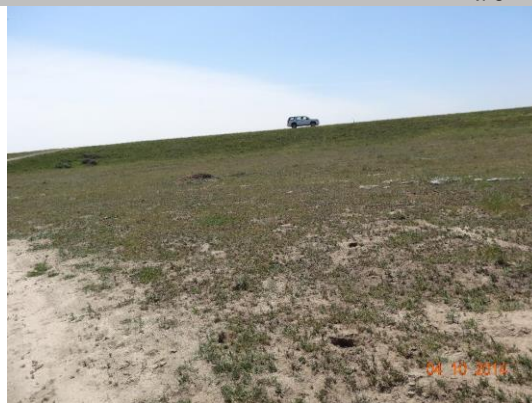
Photo 1 of 3 : UCIP_SP_2020_36693_66607.jpg

Comment Code						
Inspector Comment						
DS_ID:19882 FS_ID:36693 EP_NO: N/A Repair Type: Non-Urgent Crossing Status: Found UCIP Comments: 04/10/2014 Altered crossing--steel pipe section on landward side and concrete pipe section on waterward side. Joints on waterward side seperated. Need to contact owner to determine status. (DWR UCIP - O. Magana) FIELD_STRUCT_DESC: [Rodunder Siphon Structure] 48-inch reinforced concrete irrigation siphon pipe through the levee, 14.5 feet below the crown. Concrete U-shaped headwall on the outlet structure on the landside (LS) end. Slide gate mounted on the headwall. [Additional Reference(s): DWR Levee Log, 2002. USACE San Joaquin O&M Manual 601.1, 1967, (HLM 30.27)]. FS Date: 4/10/2014

Overview of waterward side.

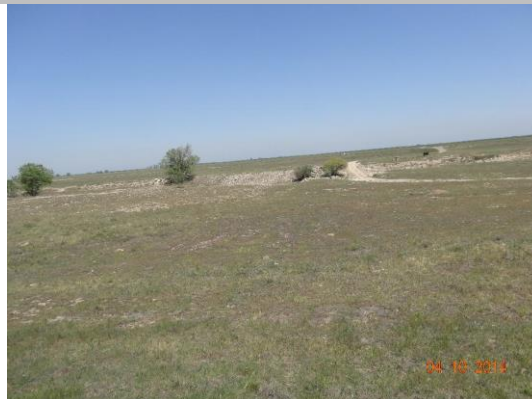
Photo 2 of 3 : UCIP_SP_2020_36693_66604.jpg

Overview of Eastside Bypass at crossing.

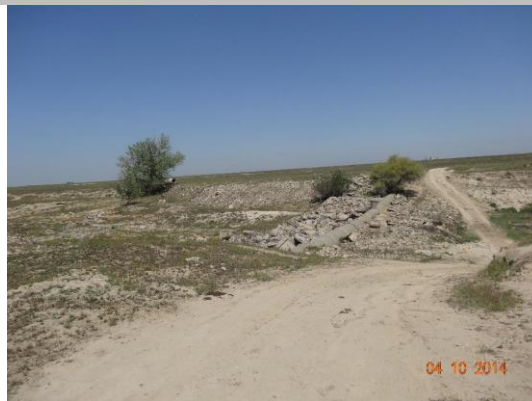
Photo 3 of 3 : UCIP_SP_2020_36693_66609.jpg

Concrete pipe through Eastside Bypass exposed.

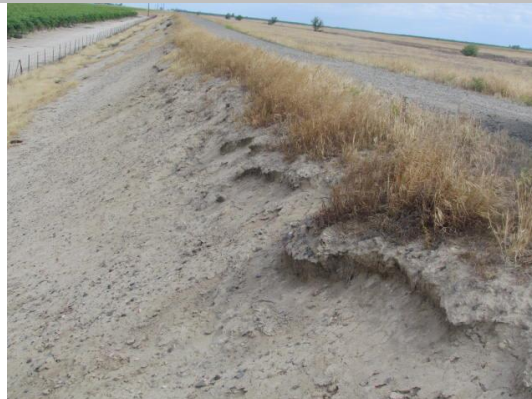
Photo 1 of 1 : SP_2020_NA0010_124_1207_20200225_00069.jpg

LM Start	30.81	Rating **	M	Issue No.	1207
LM End	31.06	Issue Type +	Ma	Location *	LS
Category	Earthen Levee			GPS Latitude/Longitude	
				Start	End
Item	Animal Control			37.021615 °	37.018428 °
				-120.437587 °	-120.435378 °
DWR ID	DWR_NA0010_06_s_2015_1207				
Comment Code					
A2 : Repair the levee slope damaged by livestock and prevent large animal access.					
Inspector Comment					
Landside erosion greater than 1" in depth and greater than 3" in length. Erosion is caused by livestock traffic.

Looking northeast at livestock erosion on landward slope.

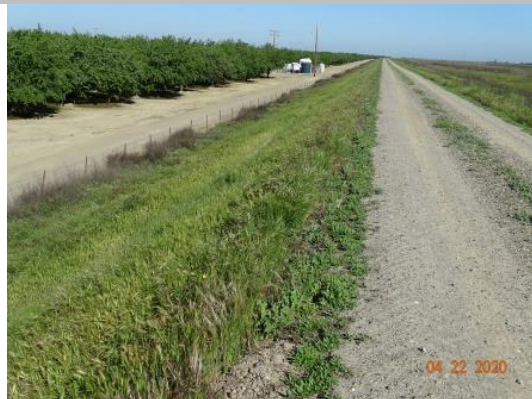
Photo 1 of 1 : SP_2020_NA0010_124_139_20200508_00217.jpg

LM Start	30.99	Rating **	M	Issue No.	139
LM End	32.49	Issue Type +	Ma	Location *	LS
Category	Earthen Levee			GPS Latitude/Longitude	
				Start	End
Item	Vegetation			37.019258 °	37.002024 °
				-120.435931 °	-120.420035 °
DWR ID	DWR_NA0010_06_s_2020_139				
Comment Code					
V1 : Control annual grass and weeds on the levee slopes and easements.					
Inspector Comment

Looking downstream along the landside slope. (Spring 2020)

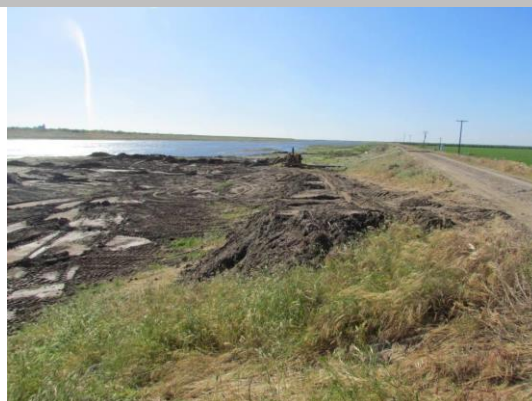
Photo 1 of 1 : SP_2020_NA0010_124_80_20200225_00026.jpg

LM Start	31.10	Rating **	U	Issue No.	80
LM End	31.10	Issue Type +	En	Location *	WS
Category	Earthen Levee			GPS Latitude/Longitude	
				Start	End
Item	Encroachments			37.017907 °	37.017907 °
				-120.434970 °	-120.434970 °
DWR ID	DWR_NA0010_06_s_2017_80				
Comment Code					
RA : Ramp					
Inspector Comment					
Farmer installed ramp on waterside slope.

Looking upstream at ramp on waterward slope.

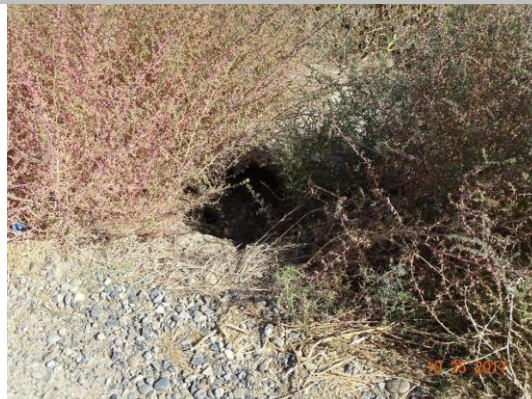
Photo 1 of 1 : SP_2020_NA0010_124_82_20200225_00028.jpg

LM Start	31.14	Rating **	U	Issue No.	82
LM End	31.14	Issue Type +	Ma	Location *	WS
Category	Earthen Levee			GPS Latitude/Longitude	
				Start	End
Item	Animal Control			37.017445 °	37.017445 °
				-120.434713 °	-120.434713 °
DWR ID	DWR_NA0010_06_f _ 2017_82				
Comment Code					
A3 : No rodents visible, but rodent burrows visible; need to backfill and compact or grout burrows.					
Inspector Comment

Looking east at the waterside slope.

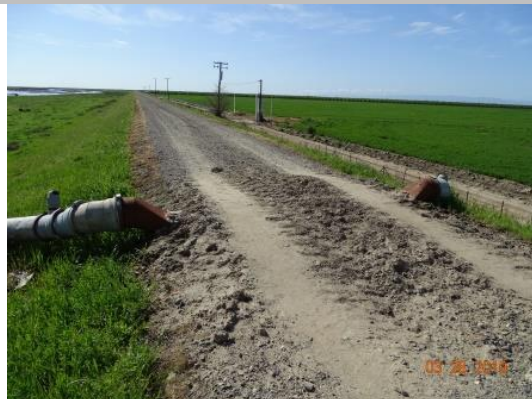
Photo 1 of 1 : SP_2020_NA0010_124_128_20200225_00063.jpg

LM Start	31.18	Rating **	M	Issue No.	128
LM End	31.18	Issue Type +	En	Location *	CR
Category	Earthen Levee			GPS Latitude/Longitude	
				Start	End
Item	Encroachments			37.016932 °	37.016932 °
				-120.434346 °	-120.434346 °
DWR ID	DWR_NA0010_06_s_2019_128				
Comment Code					
PI : Pipe					
Inspector Comment					
Temporary pipe is installed across levee crown by landowner.

View of pipe crossing looking upstream. (Spring 2019)

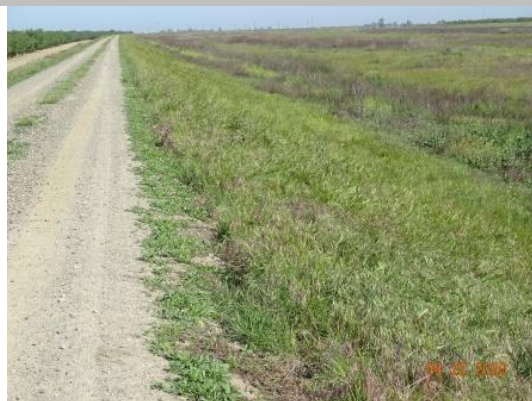
Photo 1 of 1 : SP_2020_NA0010_124_140_20200508_00218.jpg

LM Start	31.31	Rating **	U	Issue No.	140
LM End	32.49	Issue Type +	Ma	Location *	WS
Category	Earthen Levee			GPS Latitude/Longitude	
				Start	End
Item	Vegetation			37.015208 °	37.002024 °
				-120.433151 °	-120.420036 °
DWR ID	DWR_NA0010_06_s_2020_140				
Comment Code					
V1 : Control annual grass and weeds on the levee slopes and easements.					
Inspector Comment

View of vegetation on the waterside slope. (Spring 2020)

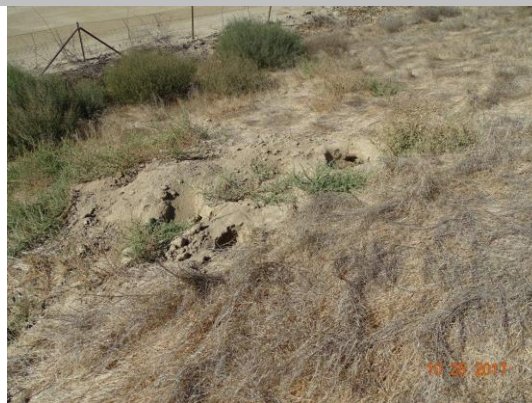
Photo 1 of 1 : SP_2020_NA0010_124_81_20200225_00027.jpg

LM Start	32.00	Rating **	U	Issue No.	81
LM End	32.00	Issue Type +	Ma	Location *	LS
Category	Earthen Levee			GPS Latitude/Longitude	
				Start	End
Item	Animal Control			37.007007 °	37.007007 °
				-120.426179 °	-120.426179 °
DWR ID	DWR_NA0010_06_f _ 2017_81				
Comment Code					
A3 : No rodents visible, but rodent burrows visible; need to backfill and compact or grout burrows.					
Inspector Comment

Looking west at the landside slope.

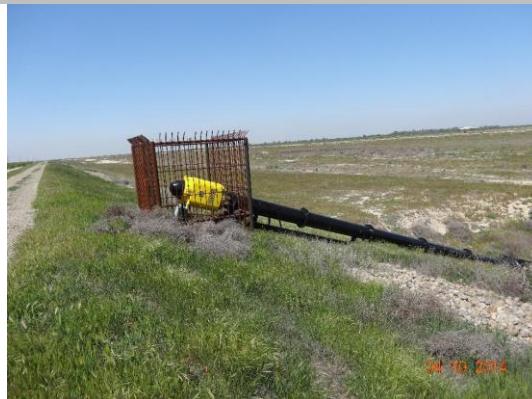
Photo 1 of 3 : UCIP_SP_2020_46183_61898.jpg

DS_ID:19883
FS_ID:46183
EP_NO: 6416A
Repair Type: Non-Urgent
Crossing Status: Found
UCIP Comments: 04/10/2014 Crossing updated--need to contact owner to determine permit issued by CVFPB for authorized changes. (DWR UCIP - O. Magana)
FIELD_STRUCT_DESC: 20-inch (not 18 inch as mentioned in the DS study) coated steel drainage discharge pipe through the levee, 3.9 feet below the crown. Electrical conduit through the levee. Cutoff wall around pipe at centerline of levee. Capped with a welded plate on the landside (LS) end. Siphon breaker on the apex of the pipe on the LS shoulder. Slant pump on the waterside (WS) slope. (To revise plans for a slant pump and an 18-inch steel pipe through the levee authorized under Permit No. 6416-A, 1975 - Triangle T. Ranch, Inc.). [Additional Reference(s): DWR Levee Log, 2002].
FS Date: 4/10/2014

View of waterward side--pipe and pump fenced off on waterward slope.

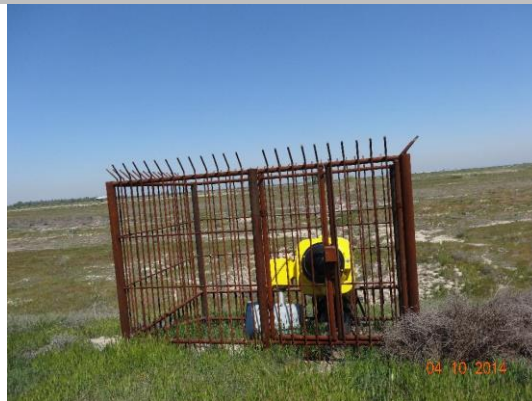
Photo 2 of 3 : UCIP_SP_2020_46183_61902.jpg

Electrical conduit visible on waterward slope.

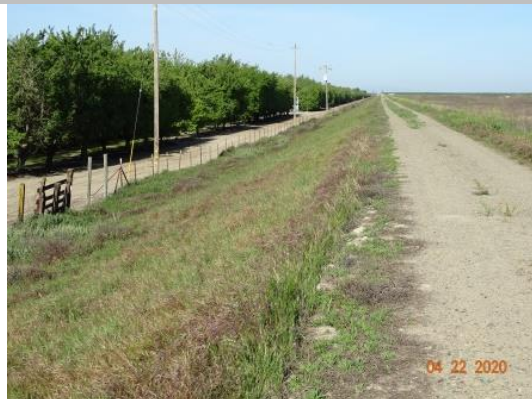
Photo 1 of 1 : SP_2020_NA0010_124_123_20200508_00219.jpg

LM Start	34.32	Rating **	U	Issue No.	123
LM End	36.45	Issue Type +	Ma	Location *	LS
Category	Earthen Levee			GPS Latitude/Longitude	
				Start	End
Item	Vegetation			36.982206 °	36.974336 °
				-120.397971 °	-120.363620 °
DWR ID	DWR_NA0010_06_s_2020_123				
Comment Code					
V1 : Control annual grass and weeds on the levee slopes and easements.					
Inspector Comment

Looking upstream along the landside slope. (Spring 2020)

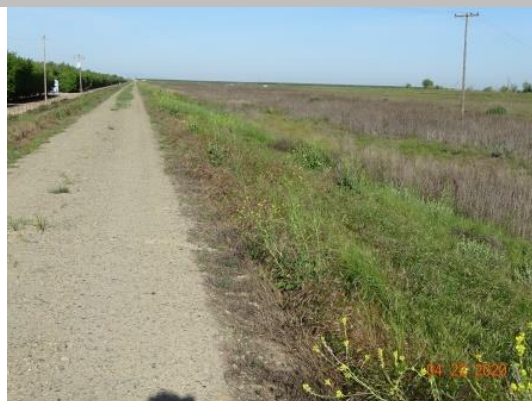
Photo 1 of 1 : SP_2020_NA0010_124_78_20200508_00220.jpg

LM Start	34.32	Rating **	U	Issue No.	78
LM End	36.46	Issue Type +	Ma	Location *	WS
Category	Earthen Levee			GPS Latitude/Longitude	
				Start	End
Item	Vegetation			36.982206 °	36.974271 °
				-120.397971 °	-120.363462 °
DWR ID	DWR_NA0010_06_s_2020_78				
Comment Code					
V1 : Control annual grass and weeds on the levee slopes and easements.					
Inspector Comment

View of the waterside slope looking downstream. (Spring 2020)

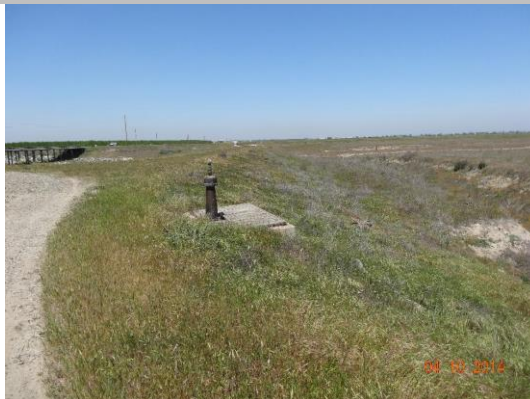
Photo 1 of 3 : UCIP_SP_2020_39481_66628.jpg

DS_ID:19813
FS_ID:39481
EP_NO: N/A
Repair Type: Non-Urgent
Crossing Status: Found
UCIP Comments: 04/10/2014 Dense vegetation limits the inspector's visibility to identify signs of pipe failure (leaks) along the slope. Recommend removing vegetation along pipe alignment to conduct proper inspection of structure and appurtenances. High vegetation along crossing alignment--recommend removing vegetation along pipe crossing. (DWR UCIP - O. Magana)
FIELD_STRUCT_DESC: [Fresno River Irrigation Structure] 48-inch by 72-inch reinforced concrete box gravity irrigation culvert through the levee, 15.1 feet below the crown. Slide gate in a concrete riser in the waterside (WS) slope. Concrete U-shaped headwall on each end. Landside (LS) channel cobble revetted for 8 feet. [Additional Reference(s): DWR Levee Log, 2002. USACE San Joaquin O&M Manual 601.1, 1967, (HLM 35.33)].
FS Date: 4/10/2014

View of waterward side--slide gate inside concrete box.

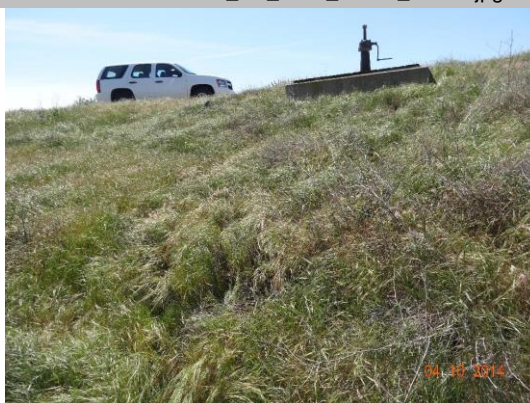
Photo 2 of 3 : UCIP_SP_2020_39481_66632.jpg

View of waterward slope covered by dense vegetation.

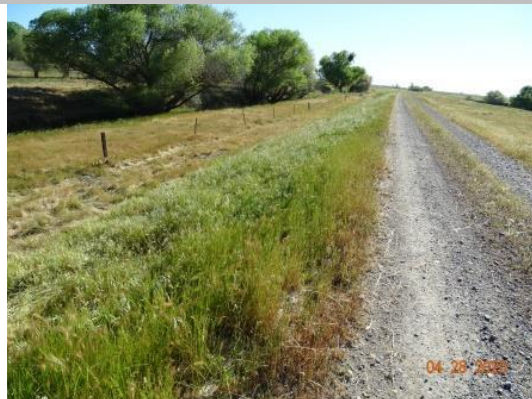
Photo 1 of 1 : SP_2020_NA0010_125_25_20200508_00048.jpg

LM Start	0.00	Rating **	U	Issue No.	25
LM End	0.18	Issue Type +	Ma	Location *	LS
Category	Earthen Levee			GPS Latitude/Longitude	
				Start	End
Item	Vegetation			37.255568 °	37.256443 °
				-120.772349 °	-120.769316 °
DWR ID	DWR_NA0010_07_s_2020_25				
Comment Code					
V1 : Control annual grass and weeds on the levee slopes and easements.					
Inspector Comment

View of vegetation on the landside slope. (Spring 2020)

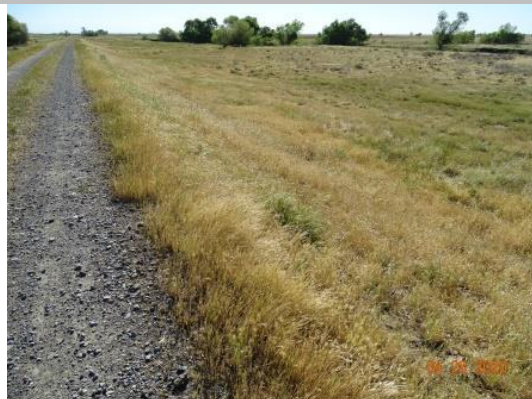
Photo 1 of 1 : SP_2020_NA0010_125_26_20200508_00049.jpg

LM Start	0.00	Rating **	M	Issue No.	26
LM End	0.69	Issue Type +	Ma	Location *	WS
Category	Earthen Levee			GPS Latitude/Longitude	
				Start	End
Item	Vegetation			37.255568 °	37.261143 °
				-120.772349 °	-120.763485 °
DWR ID	DWR_NA0010_07_s_2020_26				
Comment Code					
V1 : Control annual grass and weeds on the levee slopes and easements.					
Inspector Comment

Looking upstream along the waterside slope. (Spring 2020)

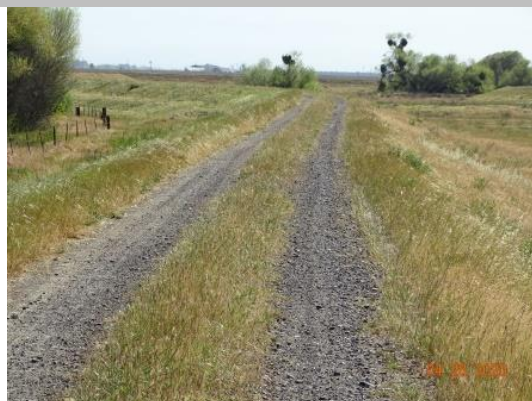
Photo 1 of 1 : SP_2020_NA0010_125_27_20200508_00050.jpg

LM Start	0.00	Rating **	M	Issue No.	27
LM End	2.10	Issue Type +	Ma	Location *	CR
Category	Earthen Levee			GPS Latitude/Longitude	
				Start	End
Item	Vegetation			37.255568 °	37.259147 °
				-120.772349 °	-120.742466 °
DWR ID	DWR_NA0010_07_s_2020_27				
Comment Code					
V9 : Keep the crown roadway free of vegetation.					
Inspector Comment

View of vegetation along the levee crown. (Spring 2020)

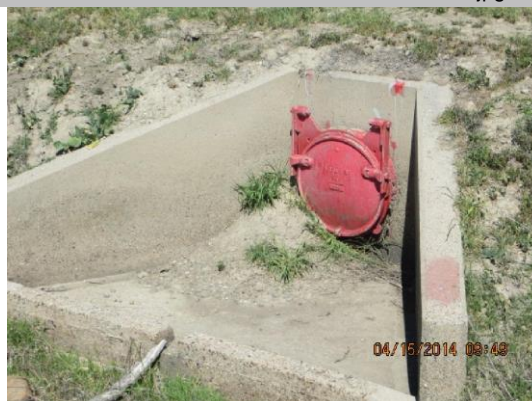
Photo 2 of 3 : UCIP_SP_2020_49966_60955.jpg

Pipe, headwall, and flapgate at WS toe. Soil buildup partially blocking flapgate.

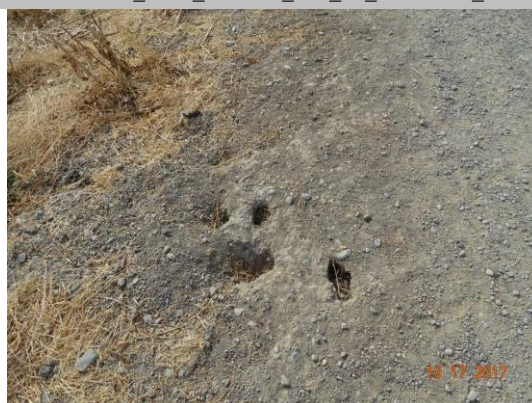
Photo 1 of 1 : SP_2020_NA0010_125_29_20200225_00013.jpg

LM Start	0.24	Rating **	M	Issue No.	29
LM End	0.50	Issue Type +	Ma	Location *	LS
Category	Earthen Levee			GPS Latitude/Longitude	
				Start	End
Item	Animal Control			37.256936 °	37.258722 °
				-120.768472 °	-120.764867 °
DWR ID	DWR_NA0010_07_s_2012_29				
Comment Code					
A3 : No rodents visible, but rodent burrows visible; need to backfill and compact or grout burrows.					
Inspector Comment					
Several rodent holes were noted on the landside and waterside slope and shoulder.

Looking north at landside slope.

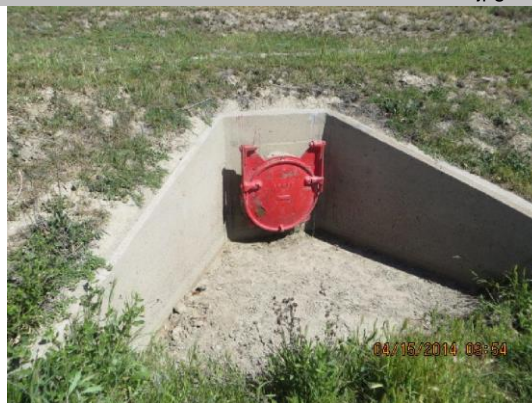
Photo 2 of 3 : UCIP_SP_2020_33712_60957.jpg

Pipe, headwall, and flapgate on WS toe.

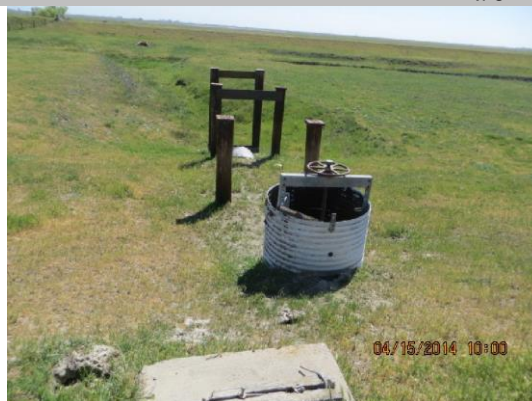
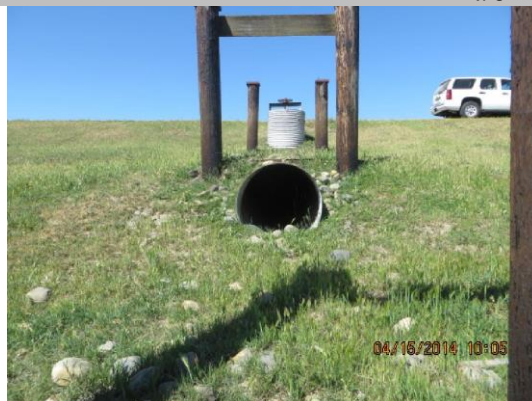
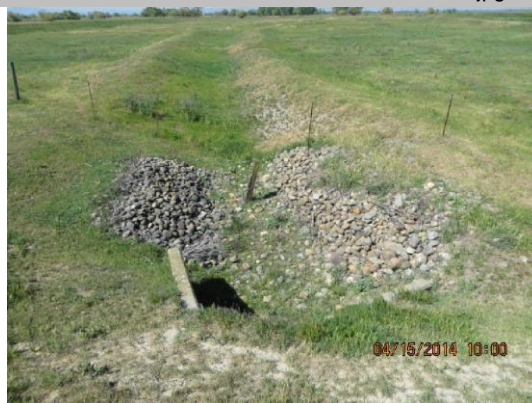
LM Start	0.49	Rating **	M	Issue No.	36
LM End	0.49	Issue Type +	Ma	Location *	
Category	Supplemental		GPS Latitude/Longitude		
			Start	End	
Item	DWR UCIP LMA Responsibility		37.258543 °	37.258543 °	
			-120.764728 °	-120.764728 °	
DWR ID	19894

DS_ID:19894
 FS_ID:33713
 EP_NO: N/A
 Repair Type: Non-Urgent
 Crossing Status: Found
 UCIP Comments: 04/15/2014 Slide gate not operable, but left in closed position. Need to reinstall covers over slide gate standpipe. (DWR UCIP - W. Wylie)
 FIELD_STRUCT_DESC: 36-inch corrugated metal gravity drainage pipe through the levee, 9.7 feet below the crown. Slide gate in a 48-inch corrugated metal pipe (CMP) riser on the landside (LS) slope. Concrete U-shaped headwall on the LS end. Inlet channel cobble revetted. Dilapidated wooden pier on the waterside (WS). WS slope and outlet ditch cobble revetted. [Additional Reference(s): DWR Levee Log, 2002. USACE San Joaquin O&M Manual 601.1, 1967, (HLM 0.49)].
 FS Date: 4/15/2014

Slide gate in CMP riser on WS slope.

Outlet on WS slope.

Pipe and headwall on LS toe.

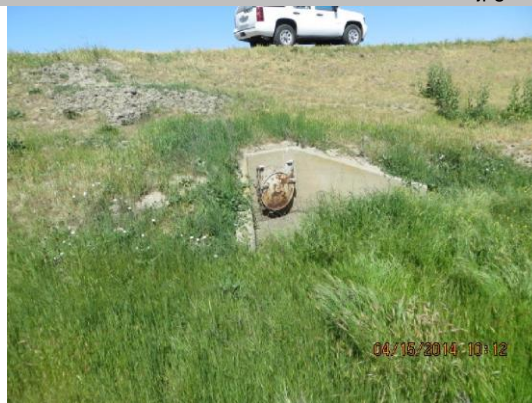
LM Start	0.53	Rating **	A/W	Issue No.	37
LM End	0.53	Issue Type +	Ma	Location *	
Category	Supplemental			GPS Latitude/Longitude	
				Start	End
Item	DWR UCIP LMA Responsibility			37.259163 °	37.259163 °
				-120.764860 °	-120.764860 °
DWR ID	19895				
Comment Code					
Inspector Comment					
DS_ID:19895 FS_ID:33723 EP_NO: N/A Repair Type: No Action Needed Crossing Status: Found UCIP Comments: FIELD_STRUCT_DESC: 24-inch corrugated metal gravity drainage pipe through the levee, 9 feet below the crown. Flap gate on the waterside (WS) end. Concrete headwall with a wooden weir at the inlet on the landside (LS) toe. Concrete U-shaped headwall on the WS toe. [Additional Reference(s): DWR Levee Log, 2002. USACE San Joaquin O&M Manual 601.1, 1967, (HLM 0.53)]. FS Date: 4/15/2014

Headwall and flapgate on WS toe.

Flapgate on concrete headwall at WS toe.

Headwall, pipe, and wier on LS toe.

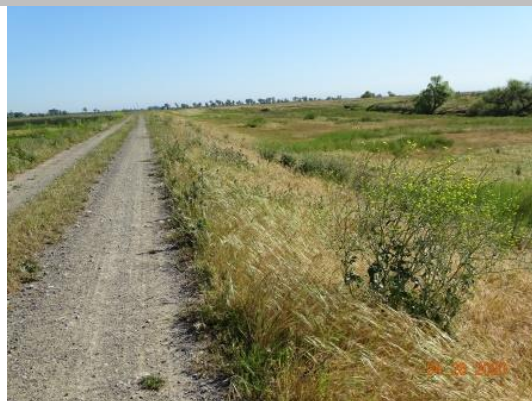
Photo 1 of 1 : SP_2020_NA0010_125_31_20200508_00051.jpg

LM Start	0.69	Rating **	U	Issue No.	31
LM End	0.93	Issue Type +	Ma	Location *	WS
Category	Earthen Levee			GPS Latitude/Longitude	
				Start	End
Item	Vegetation			37.261143 °	37.263795 °
				-120.763485 °	-120.760751 °
DWR ID	DWR_NA0010_07_s_2020_31				
Comment Code					
V1 : Control annual grass and weeds on the levee slopes and easements.					
Inspector Comment

View of the waterside slope looking upstream. (Spring 2020)

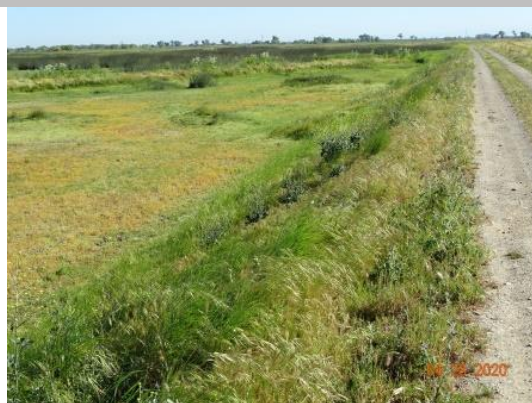
Photo 1 of 1 : SP_2020_NA0010_125_30_20200508_00052.jpg

LM Start	0.69	Rating **	U	Issue No.	30
LM End	3.59	Issue Type +	Ma	Location *	LS
Category	Earthen Levee			GPS Latitude/Longitude	
				Start	End
Item	Vegetation			37.261143 °	37.254693 °
				-120.763485 °	-120.720173 °
DWR ID	DWR_NA0010_07_s_2020_30				
Comment Code					
V1 : Control annual grass and weeds on the levee slopes and easements.					
Inspector Comment

view of vegetation on the landside slope. (Spring 2020)

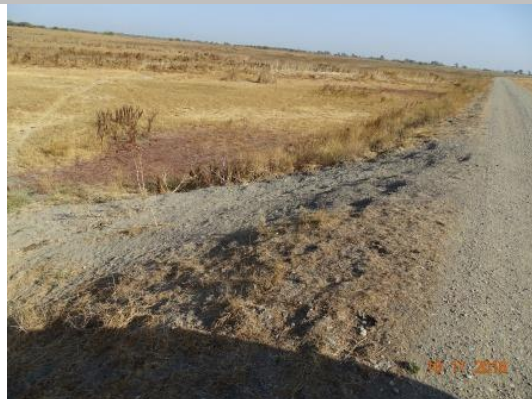
Photo 1 of 1 : SP_2020_NA0010_125_19_20200225_00011.jpg

LM Start	0.70	Rating **	M	Issue No.	19
LM End	0.70	Issue Type +	Ma	Location *	LS
Category	Earthen Levee			GPS Latitude/Longitude	
				Start	End
Item	Animal Control			37.261337 °	37.261337 °
				-120.763303 °	-120.763303 °
DWR ID	DWR_NA0010_07_f _ 2018_19				
Comment Code					
A2 : Repair the levee slope damaged by livestock and prevent large animal access.					
Inspector Comment					
There is livestock damage to the landside slope.

Damage to landside slope from livestock. (Fall 2018)

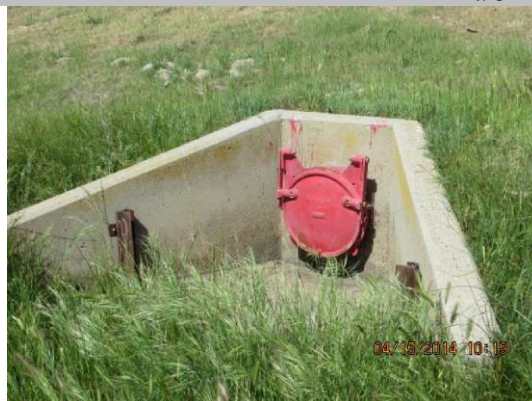
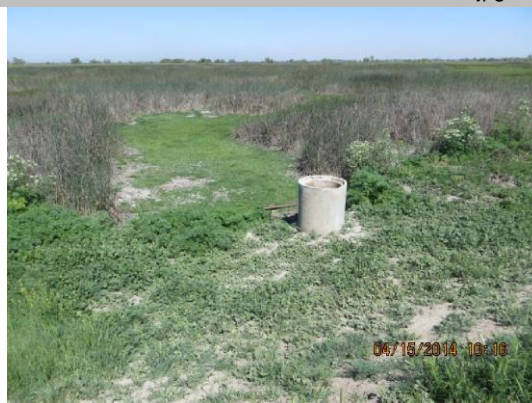
LM Start	0.85	Rating **	M	Issue No.	38	
LM End	0.85	Issue Type +	Ma	Location *		
Category	Supplemental			GPS Latitude/Longitude		
				Start	End	
Item	DWR UCIP LMA Responsibility			37.262981 °	37.262981 °	
				-120.761703 °	-120.761703 °	
DWR ID	19896

Comment Code						
Inspector Comment						
DS_ID:19896 FS_ID:39507 EP_NO: N/A Repair Type: Non-Urgent Crossing Status: Found UCIP Comments: 04/15/2014 Need to contact owner. Heavy sediment buildup at inlet due to animal activity should be cleared. (DWR UCIP - W. Wylie) FIELD_STRUCT_DESC: 24-inch corrugated metal gravity drainage pipe through the levee, 9.8 feet below the crown. Flap gate on the waterside (WS) end. Wooden weir on concrete headwall at the landside (LS) toe. 36-inch concrete riser at the LS toe. Concrete U-shaped headwall on the WS end. Concrete standpipe on the LS. [Additional Reference(s): DWR Levee Log, 2002. USACE San Joaquin O&M Manual 601.1, 1967, (HLM 0.85)]. FS Date: 4/15/2014

Headwall and flapgate on WS toe.

Concrete riser, concrete headwall, weir, and pipe at LS toe.

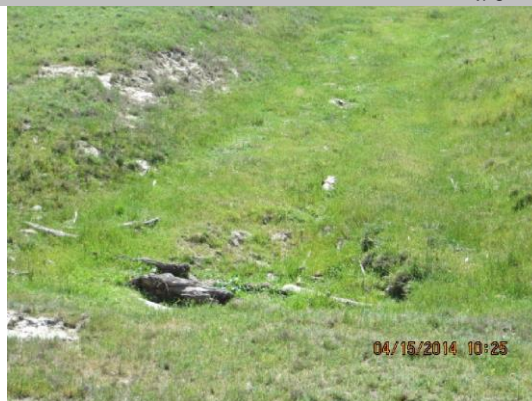
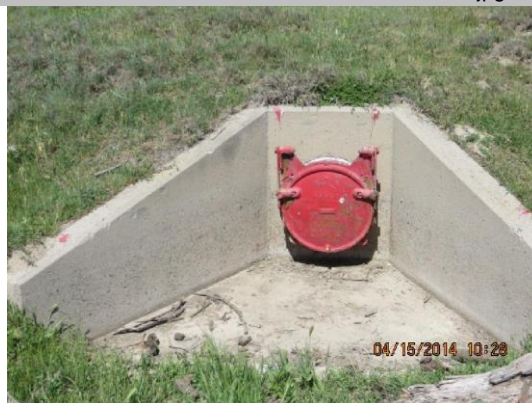
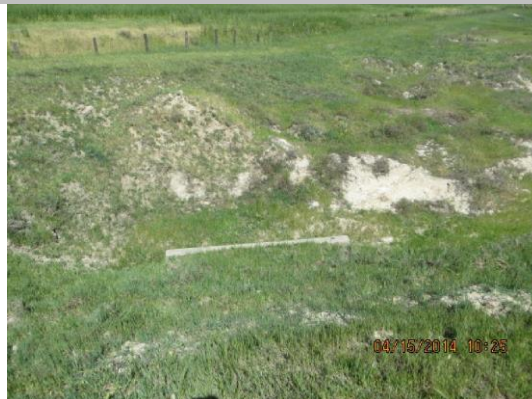
LM Start	0.94	Rating **	A/W	Issue No.	39
LM End	0.94	Issue Type +	Ma	Location *	
Category	Supplemental			GPS Latitude/Longitude	
				Start	End
Item	DWR UCIP LMA Responsibility			37.263950 °	37.263950 °
				-120.760572 °	-120.760572 °
DWR ID	19897				
Comment Code					
Inspector Comment					
DS_ID:19897 FS_ID:33725 EP_NO: N/A Repair Type: No Action Needed Crossing Status: Found UCIP Comments: FIELD_STRUCT_DESC: 24-inch corrugated metal gravity drainage pipe through the levee, 11.5 feet below the crown. Flap gate on the waterside (WS) end. Concrete headwall on the landside (LS) end. Concrete U-shaped headwall on the WS end. [Additional Reference(s): DWR Levee Log, 2002. USACE San Joaquin O&M Manual 601.1, 1967, (HLM 0.94)]. FS Date: 4/15/2014

Concrete headwall and flapgate at WS toe.

Concrete headwall and pipe on LS toe.

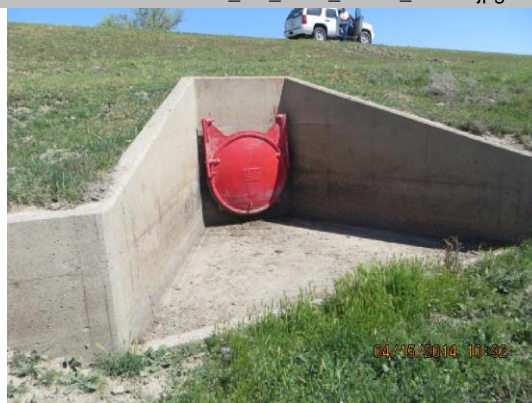
LM Start	1.17	Rating **	A/W	Issue No.	40	
LM End	1.17	Issue Type +	Ma	Location *		
Category	Supplemental			GPS Latitude/Longitude		
				Start	End	
Item	DWR UCIP LMA Responsibility			37.264421 °	37.264421 °	
				-120.756683 °	-120.756683 °	
DWR ID	19898					
Comment Code						
Inspector Comment						
DS_ID:19898						
FS_ID:33726						
EP_NO: N/A						
Repair Type: No Action Needed						
Crossing Status: Found						
UCIP Comments:						
FIELD_STRUCT_DESC: 48-inch corrugated metal gravity drainage pipe through the levee, 14.6 feet below the crown. Flap gate on the waterside (WS) end. Concrete U-shaped headwall on each end.						
[Additional Reference(s): DWR Levee Log, 2002. USACE San Joaquin O&M Manual 601.1, 1967, (HLM 1.17)].						
FS Date: 4/15/2014

Pipe, flapgate, and headwall on WS toe.

Flapgate at headwall on WS toe.

Pipe and headwall on LS toe.

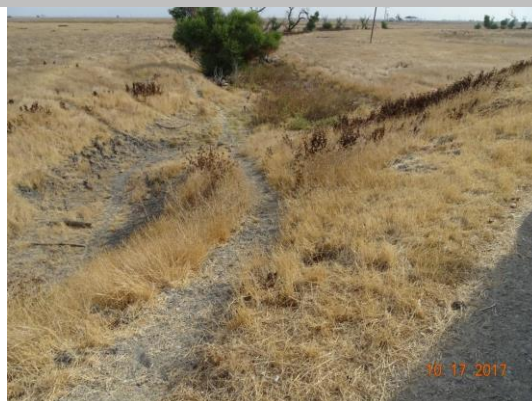
Photo 1 of 1 : SP_2020_NA0010_125_16_20200225_00007.jpg

LM Start	1.49	Rating **	A/W	Issue No.	16
LM End	1.49	Issue Type +	Ma	Location *	LS
Category	Earthen Levee			GPS Latitude/Longitude	
				Start	End
Item	Animal Control			37.263999 °	37.263999 °
				-120.750854 °	-120.750854 °
DWR ID	DWR_NA0010_07_f_2017_16				
Comment Code					
A2 : Repair the levee slope damaged by livestock and prevent large animal access.					
Inspector Comment					
Repair slope damaged by animal traffic.

Looking east at landside slope.

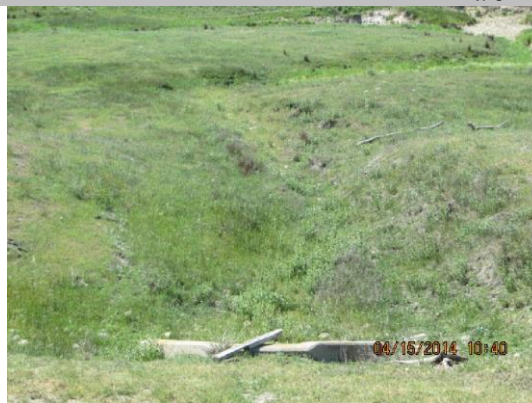
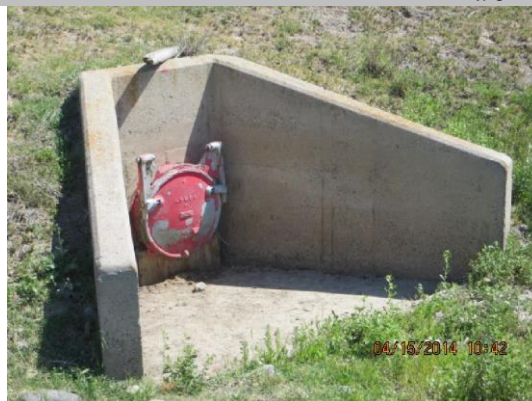
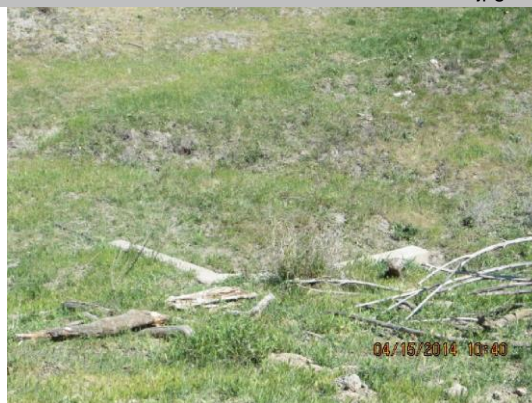
LM Start	1.50	Rating **	A/W	Issue No.	41
LM End	1.50	Issue Type +	Ma	Location *	
Category	Supplemental			GPS Latitude/Longitude	
				Start	End
Item	DWR UCIP LMA Responsibility			37.263917 °	37.263917 °
				-120.750694 °	-120.750694 °
DWR ID	19902				
Comment Code					
Inspector Comment					
DS_ID:19902 FS_ID:33727 EP_NO: N/A Repair Type: No Action Needed Crossing Status: Found UCIP Comments: FIELD_STRUCT_DESC: 24-inch corrugated metal gravity drainage pipe through the levee, 14 feet below the crown. Flap gate on the waterside (WS) end. Concrete U-shaped headwall on each end. [Additional Reference(s): DWR Levee Log, 2002. USACE San Joaquin O&M Manual 601.1, 1967, (HLM 1.51)]. FS Date: 4/15/2014

Pipe, headwall and flapgate on WS toe.

Headwall and pipe on LS toe.

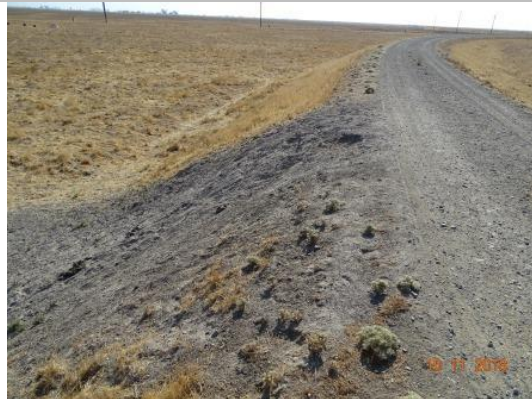
Photo 1 of 1 : SP_2020_NA0010_125_21_20200225_00012.jpg

LM Start	1.90	Rating **	M	Issue No.	21
LM End	1.90	Issue Type +	Ma	Location *	LS
Category	Earthen Levee			GPS Latitude/Longitude	
				Start	End
Item	Animal Control			37.261379 °	37.261379 °
				-120.744228 °	-120.744228 °
DWR ID	DWR_NA0010_07_f_2018_21				
Comment Code					
A2 : Repair the levee slope damaged by livestock and prevent large animal access.					
Inspector Comment

Slope damage from livestock. (Fall 2018)

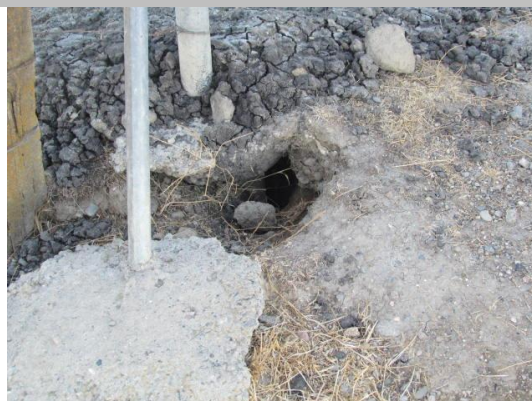
Photo 1 of 1 : SP_2020_NA0010_125_12_20200225_00005.jpg

LM Start	2.09	Rating **	M	Issue No.	12
LM End	2.09	Issue Type +	Ma	Location *	LS
Category	Earthen Levee			GPS Latitude/Longitude	
				Start	End
Item	Animal Control			37.259187 °	37.259187 °
				-120.742551 °	-120.742551 °
DWR ID	DWR_NA0010_07_f_2018_12				
Comment Code					
A3 : No rodents visible, but rodent burrows visible; need to backfill and compact or grout burrows.					
Inspector Comment					
Rodent activity is noted next to the fence post.

Looking east at rodent hole next to fence post on landward shoulder.

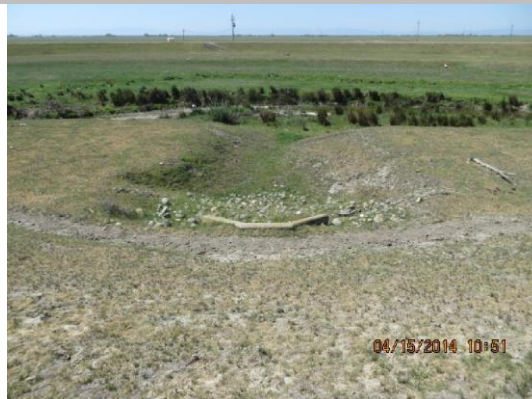
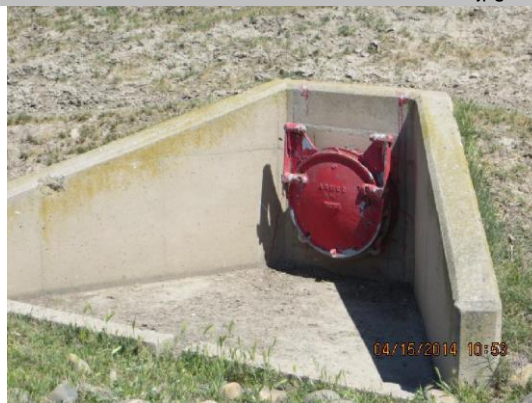
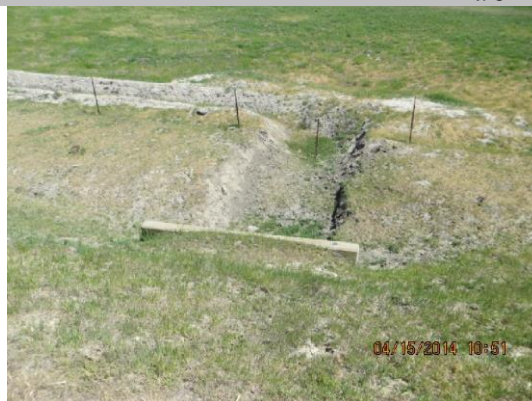
LM Start	2.48	Rating **	A/W	Issue No.	42
LM End	2.48	Issue Type +	Ma	Location *	
Category	Supplemental			GPS Latitude/Longitude	
				Start	End
Item	DWR UCIP LMA Responsibility			37.255803 °	37.255803 °
				-120.737246 °	-120.737246 °
DWR ID	19899				
Comment Code					
Inspector Comment					
DS_ID:19899 FS_ID:33728 EP_NO: N/A Repair Type: No Action Needed Crossing Status: Found UCIP Comments: FIELD_STRUCT_DESC: 24-inch corrugated metal gravity drainage pipe through the levee, 9.5 feet below the crown. Flap gate on the waterside (WS) end. Concrete headwall on the landside (LS) end. Concrete U-shaped headwall on the WS end. [Additional Reference(s): DWR Levee Log, 2002. USACE San Joaquin O&M Manual 601.1, 1967, (HLM 2.48)]. FS Date: 4/15/2014

Headwall and flapgate on WS toe.

Concrete headwall and flapgate at WS toe.

Concrete headwall and pipe on LS toe.

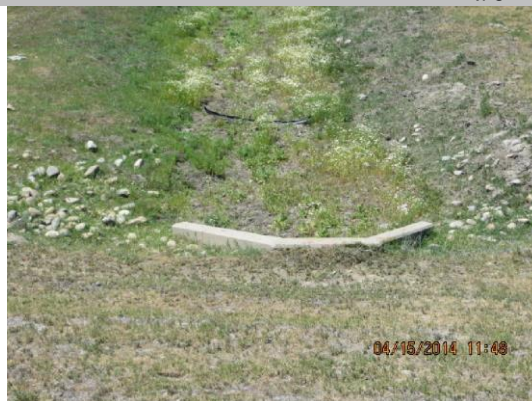
DS_ID:19900
 FS_ID:33729
 EP_NO: N/A
 Repair Type: No Action Needed
 Crossing Status: Found
 UCIP Comments:
 FIELD_STRUCT_DESC: 24-inch corrugated metal gravity drainage pipe through the levee, 11.5 feet below the crown. Flap gate on the waterside (WS) end. Concrete headwall on the landside (LS) end. Concrete U-shaped headwall on the WS end. [Additional Reference(s): DWR Levee Log, 2002. USACE San Joaquin O&M Manual 601.1, 1967, (HLM 2.64)].
 FS Date: 4/15/2014

Concrete headwall and flapgate on WS toe.

Concrete headwall and pipe at LS toe.

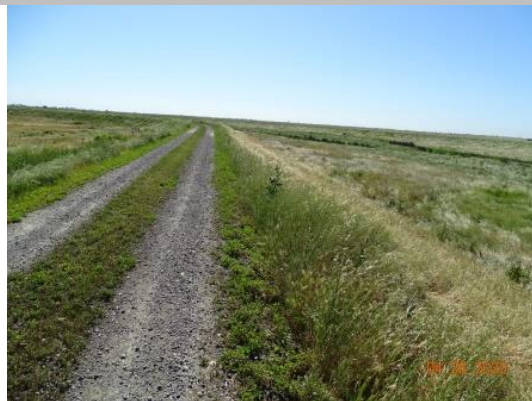
Photo 1 of 1 : SP_2020_NA0010_125_32_20200508_00053.jpg

LM Start	2.99	Rating **	U	Issue No.	32
LM End	3.59	Issue Type +	Ma	Location *	WS
Category	Earthen Levee			GPS Latitude/Longitude	
				Start	End
Item	Vegetation			37.251958 °	37.254693 °
				-120.729933 °	-120.720173 °
DWR ID	DWR_NA0010_07_s_2020_32				
Comment Code					
V1 : Control annual grass and weeds on the levee slopes and easements.					
Inspector Comment

Looking upstream along the waterside slope. (Spring 2020)

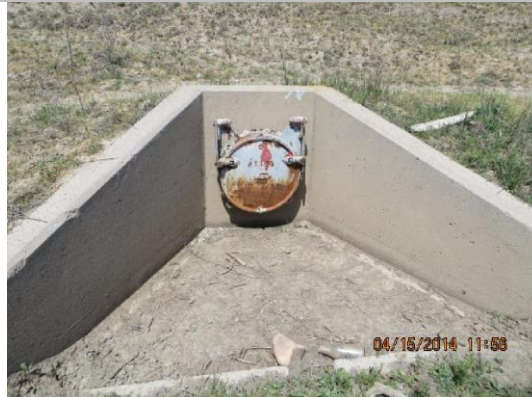
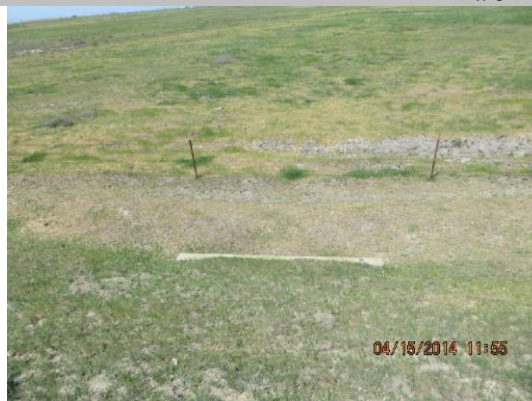
LM Start	3.09	Rating **	M	Issue No.	44	
LM End	3.09	Issue Type +	Ma	Location *		
Category	Supplemental			GPS Latitude/Longitude		
				Start		End
Item	DWR UCIP LMA Responsibility			37.251883 °	37.251883 °	
				-120.728264 °	-120.728264 °	
DWR ID	19901					
Comment Code						
Inspector Comment						
DS_ID:19901 FS_ID:39508 EP_NO: N/A Repair Type: Non-Urgent Crossing Status: Found UCIP Comments: 04/15/2014 Some sediment buildup at landward toe and inside pipe--recommend clearing. (DWR UCIP - W. Wylie) FIELD_STRUCT_DESC: 24-inch corrugated metal gravity drainage pipe through the levee, 10.4 feet below the crown. Flap gate on the waterside (WS) end. Concrete headwall on the landside (LS) end. Concrete U-shaped headwall on the WS end. [Additional Reference(s): DWR Levee Log, 2002. USACE San Joaquin O&M Manual 601.1, 1967, (HLM 3.09)]. FS Date: 4/15/2014

Headwall, pipe, and flapgate on WS toe.

Headwall and pipe on LS toe.

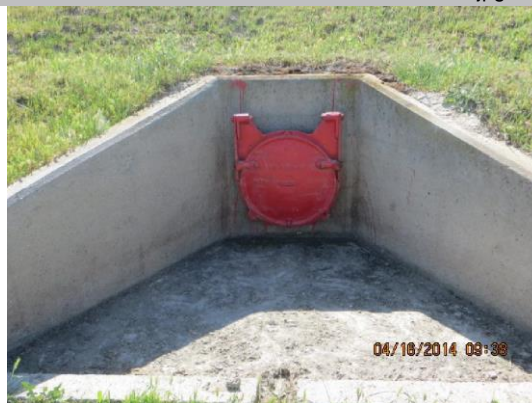
LM Start	0.23	Rating **	A/W	Issue No.	36
LM End	0.23	Issue Type +	Ma	Location *	
Category	Supplemental			GPS Latitude/Longitude	
				Start	End
Item	DWR UCIP LMA Responsibility			37.256092 °	37.256092 °
				-120.767873 °	-120.767873 °
DWR ID	19903				
Comment Code					
Inspector Comment					
DS_ID:19903 FS_ID:33751 EP_NO: N/A Repair Type: No Action Needed Crossing Status: Found UCIP Comments: FIELD_STRUCT_DESC: 24-inch corrugated metal gravity drainage pipe through the levee, 9.6 feet below the crown. Flap gate on the waterside (WS) end. Concrete headwall on the landside (LS) end. Concrete U-shaped headwall on the WS end. [Additional Reference(s): DWR Levee Log, 2002. USACE San Joaquin O&M Manual 601.1, 1967, (HLM 0.23)]. FS Date: 4/16/2014

Headwall and flapgate on WS toe.

Concrete headwall on LS toe.

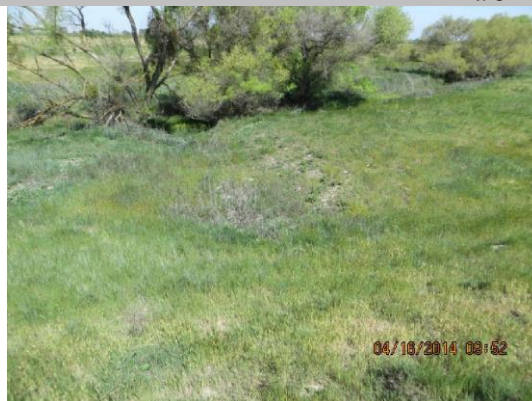
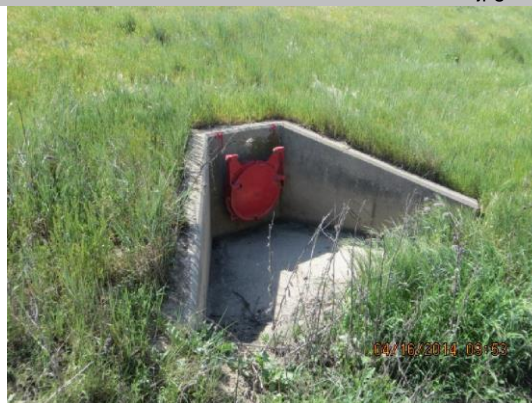
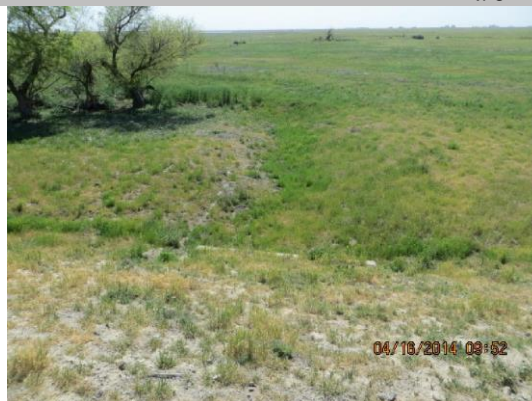
LM Start	0.72	Rating **	A/W	Issue No.	38
LM End	0.72	Issue Type +	Ma	Location *	
Category	Supplemental			GPS Latitude/Longitude	
				Start	End
Item	DWR UCIP LMA Responsibility			37.260306 °	37.260306 °
				-120.762127 °	-120.762127 °
DWR ID	19905				
Comment Code					
Inspector Comment					
DS_ID:19905 FS_ID:33753 EP_NO: N/A Repair Type: No Action Needed Crossing Status: Found UCIP Comments: FIELD_STRUCT_DESC: 24-inch corrugated metal gravity drainage pipe through the levee, 10 feet below the crown. Flap gate on the waterside (WS) end. Concrete headwall on each end. [Additional Reference(s): DWR Levee Log, 2002. USACE San Joaquin O&M Manual 601.1, 1967, (HLM 0.72)]. FS Date: 4/16/2014

Headwall and flapgate at WS toe.

Concrete headwall on LS toe.

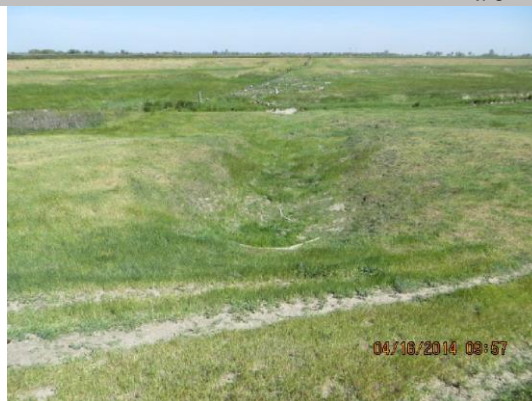
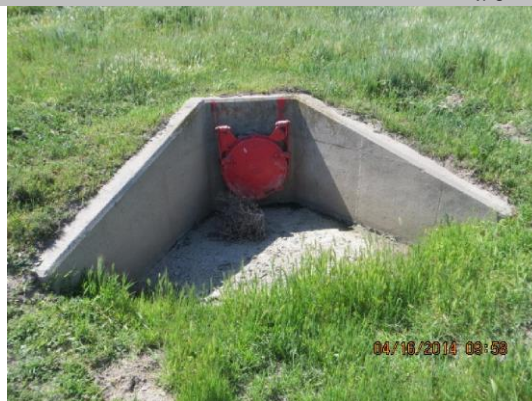
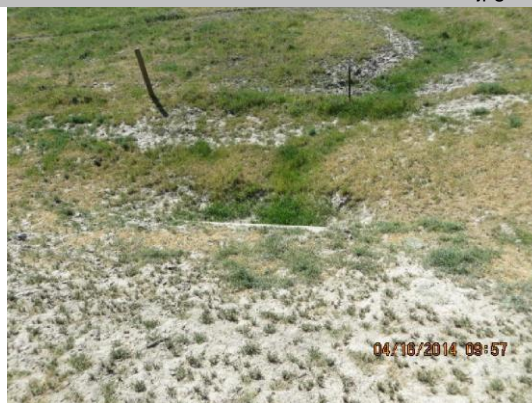
DS_ID:19832
 FS_ID:39887
 EP_NO: N/A
 Repair Type: Non-Urgent
 Crossing Status: Found
 UCIP Comments: 04/16/2014 Some sediment buildup at inlet on LS toe. (DWR UCIP - W. Wylie)
 FIELD_STRUCT_DESC: 24-inch corrugated metal gravity drainage pipe through the levee, 11.5 feet below the crown. Flap gate on the waterside (WS) end. Concrete headwall on each end. [Additional Reference(s): DWR Levee Log, 2002. USACE San Joaquin O&M Manual 601.1, 1967, (HLM 0.89)].
 FS Date: 4/16/2014

Headwall, pipe, and flapgate on WS toe.

Pipe and headwall on LS toe.

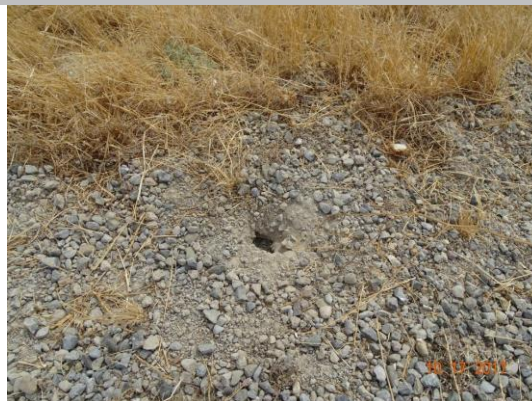
Photo 1 of 1 : SP_2020_NA0010_126_2_20200225_00001.jpg

LM Start	1.20	Rating **	M	Issue No.	2
LM End	1.20	Issue Type +	Ma	Location *	LS
Category	Earthen Levee			GPS Latitude/Longitude	
				Start	End
Item	Animal Control			37.263182 °	37.263183 °
				-120.755650 °	-120.755637 °
DWR ID	DWR_NA0010_08_s_2012_2				
Comment Code					
A3 : No rodents visible, but rodent burrows visible; need to backfill and compact or grout burrows.					
Inspector Comment

Looking south at the landside shoulder.

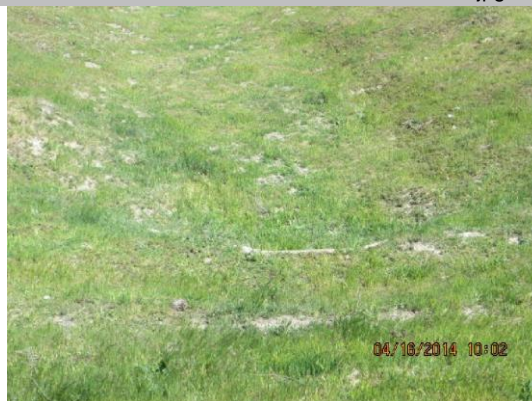
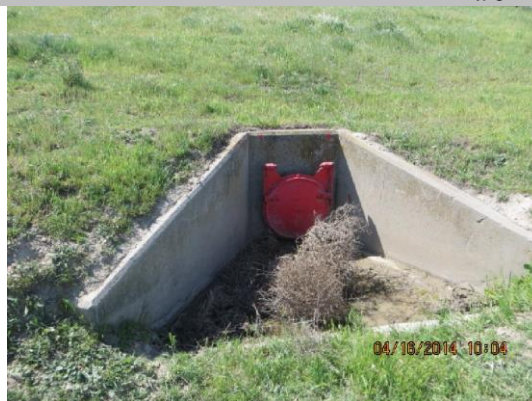
LM Start	1.21	Rating **	M	Issue No.	40
LM End	1.21	Issue Type +	Ma	Location *	
Category	Supplemental			GPS Latitude/Longitude	
				Start	End
Item	DWR UCIP LMA Responsibility			37.263188 °	37.263188 °
				-120.755399 °	-120.755399 °
DWR ID	19833				
Comment Code					
Inspector Comment					
DS_ID:19833 FS_ID:39509 EP_NO: N/A Repair Type: Non-Urgent Crossing Status: Found UCIP Comments: 04/16/2014 Debris blocking landward headwall--recommend clearing. (DWR UCIP - W. Wylie) FIELD_STRUCT_DESC: 24-inch corrugated metal gravity drainage pipe through the levee, 11.6 feet below the crown. Flap gate on the waterside (WS) end. Concrete headwall on each end. [Additional Reference(s): DWR Levee Log, 2002. USACE San Joaquin O&M Manual 601.1, 1967, (HLM 1.21)]. FS Date: 4/16/2014

Concrete headwall, pipe, and flapgate on WS toe.

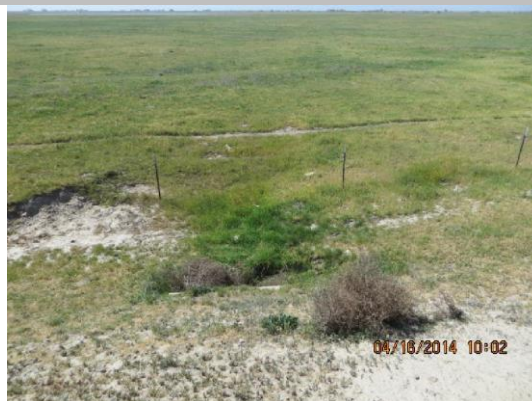
Photo 3 of 3 : UCIP_SP_2020_39509_61089.jpg

Pipe and headwall on LS toe.
